POWER MOVE

JAKUB KARAS DETAILS A PROJECT INVESTIGATING WHETHER UAVS FITTED WITH THERMAL IMAGING EQUIPMENT, CAMERAS AND RADAR COULD SAFELY SURVEY POWER LINES IN THE CZECH REPUBLIC

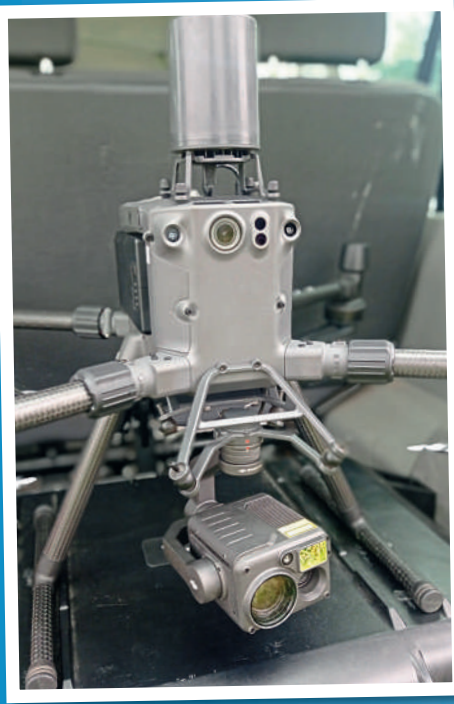
The DJI M300RTK fitted with a radar for detecting wires

In addition to the optical sensors monitoring the environment for possible obstacle avoidance, this UAV also has a radar located on top that can identify even thin wires of power lines and thus always stop the UAV automatically in time

according to the safety limit settings.

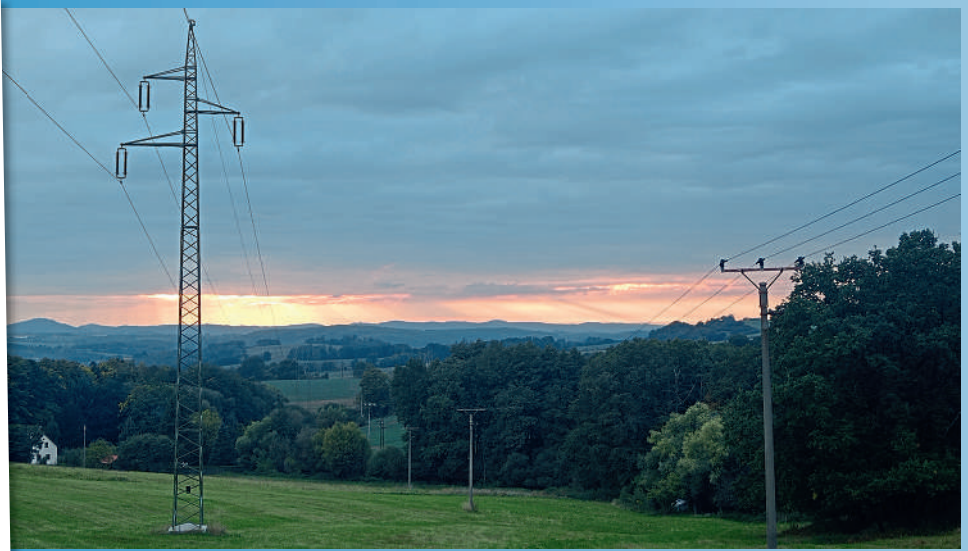
Two types of poles inspected from UAVs with different voltages

A zooming RGB camera in high resolution mode was always used for the image inspection, which recorded the pole from the ground to its top in several tiles. This was done from both sides of the pole, always at a height of several metres obliquely in front of and behind the pole. The number of tiles was always chosen according to the distance of the UAV from the pole and any constraints on the UAV's approach to the pole and the size of the UAV.

At the same time, the UAV recorded from a closer distance a thermal photo of the top of each pole with insulators. Thermal recording has greater limitations compared to RGB images because it doesn't allow for zooming, even though the image resolution of the thermal cameras available for UAVs is only 640x512px. This means the UAV needs to be closer to the pole.

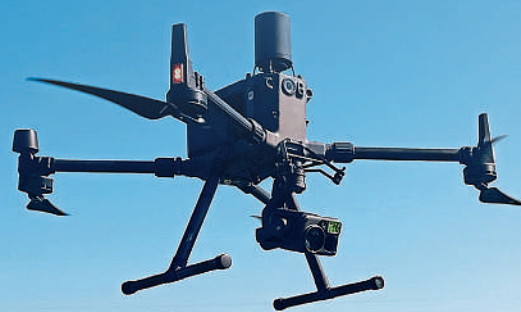
DJI M300 RTK with radar and RGB camera, 23x optical zoom and thermal camera

Based on the tests carried out in the pilot project in the Ore Mountains, there was a need to use UAVs with long range and battery life, which is the domain of the new DJI Matrice 300 UAV with RTK and having an RGB sensor and a thermal camera integrated into one sensor H20T with 23x optical zoom. For the most efficient flying around poles, ensuring safety and the possibility of operating the UAV, it was necessary to have a camera that allows a large zoom of the details of the poles from an oblique view from above and without necessarily moving the UAV within the protection zone.
